# Manhole Inspection Summary

Manhole # S21G\_\_067MH

Insp Date: **8/23/07 11:09 AM**

**Location** Address: **1722 BALTIMORE ST**

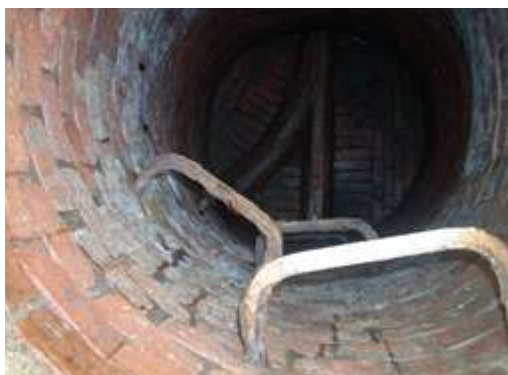
Defect 2

Count: **7** Missing: **0** ☒ **Corroded**

CORRODED STEPS

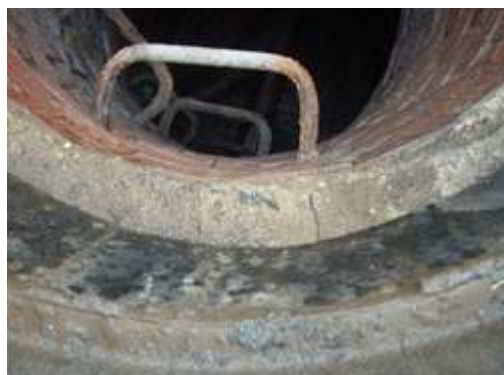
Defect 1

Offset: **2** (in.)

FRAME OFFSET

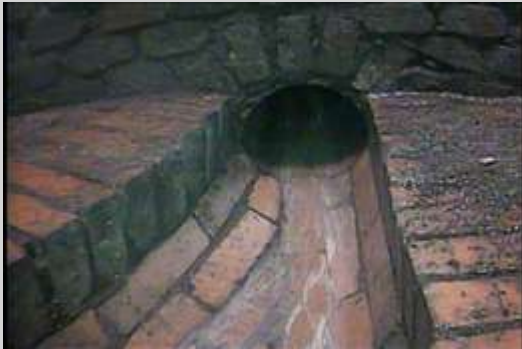
12 O'Clock Outflow

8 in. Circular Gravity Sewer  
Pipe Out @ 12 O'Clock

Pipe Height: **8.4** (in.) Rod and Bar (Angled)  
Pipe Material: **Clay** ☐ Pipe Lined  
Invert Depth: **12.19** (ft.) Flow Characteristics: **Fast**  
Deposits: ☒ None ☐ Mud ☐ Sludge ☐ Debris ☐ Grease  
Silt Depth: (in.) Deposits Extent:  
Infiltration: **None** Pipe Seal Cond: **Sound**

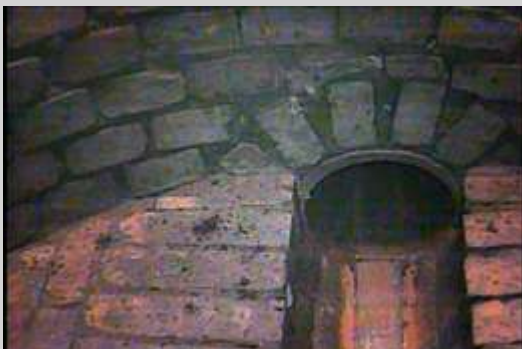
6 O'Clock Inflow

8 in. Circular Gravity Sewer  
Pipe In @ 6 O'Clock

Pipe Height: **8.4** (in.) Rod and Bar (Angled)  
Pipe Material: **Clay** ☐ Pipe Lined  
Invert Depth: **11.83** (ft.) Flow Characteristics: **Fast**  
Deposits: ☒ None ☐ Mud ☐ Sludge ☐ Debris ☐ Grease  
Silt Depth: (in.) Deposits Extent:  
Infiltration: **None** Pipe Seal Cond: **Sound**

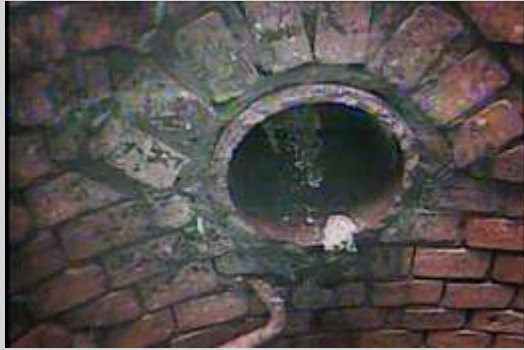
8 O'Clock Inflow

FRAME OFFSET

Pipe Height: **7.2** (in.) Rod and Bar (Angled)

Drop: **Outside** Rod and Bar
